Re: Former Roth Bros. Smelting Corp. Site
6223 Thompson Road, Dewitt, New York
Consent Order C7-0001-94-10

Annual Asphalt Cap Inspection

Re. CAMU Cover Repairs

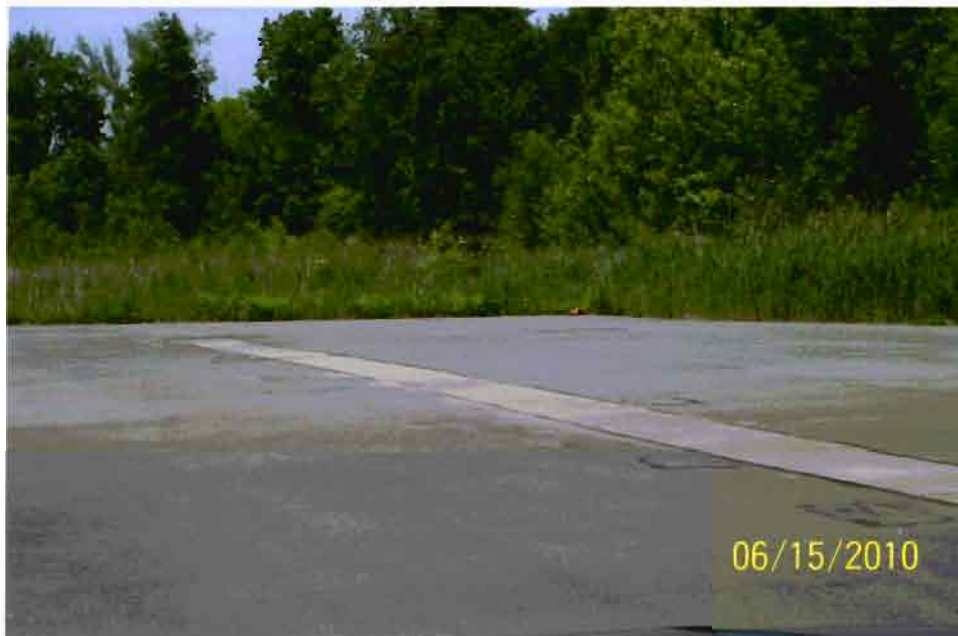
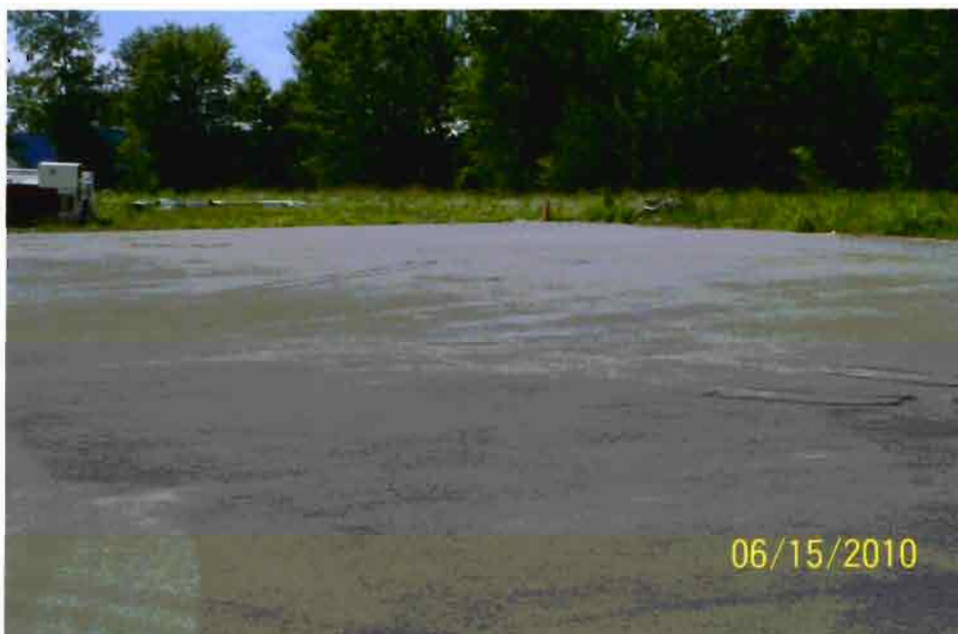
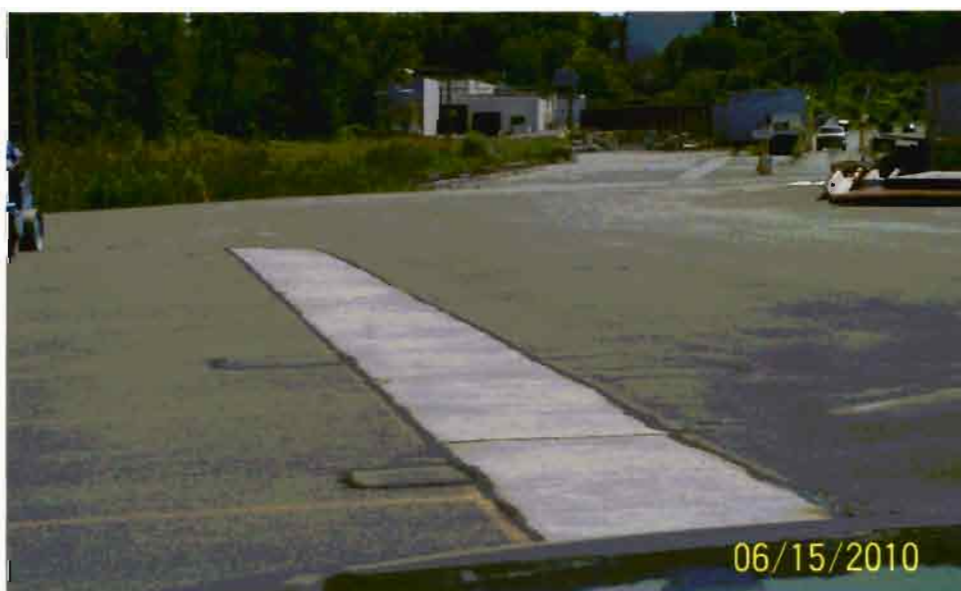
I have completed the inspection of the asphalt cover on the CAMU area. I have found a few minor areas of damage to the asphalt pavement and a few spots of vegetation growing along the joint between the concrete dolly apron and asphalt pavement. Vegetation is also growing along the slope on the east side but has not entered the CAMU cap area.

Fill depressions with hot mix asphalt and crack seal edges.
Treat all vegetation with a non selective herbicide (Round-up).

All repairs were completed by June 16, 2010.
